# REPAIR REPORT

**YAW MOTORGEAR "SOM"**

**TYPE PG-1004 PR**

**CLIENT: CCR WIND SOLAR CONSULTING**

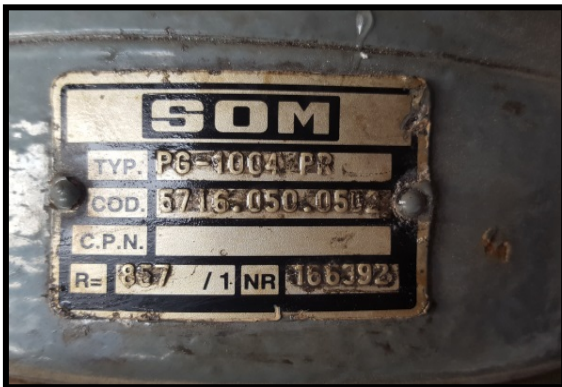
Fig. 1. Identification plate.

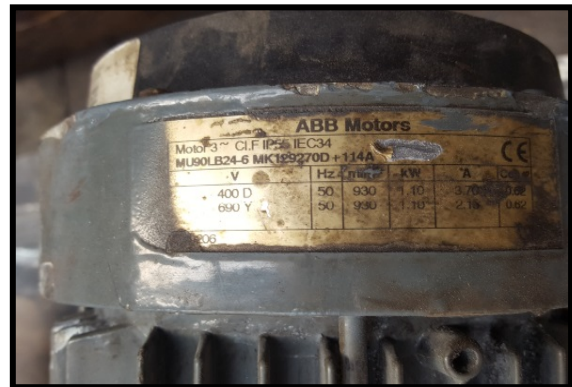
Fig. 2. Electric motor.

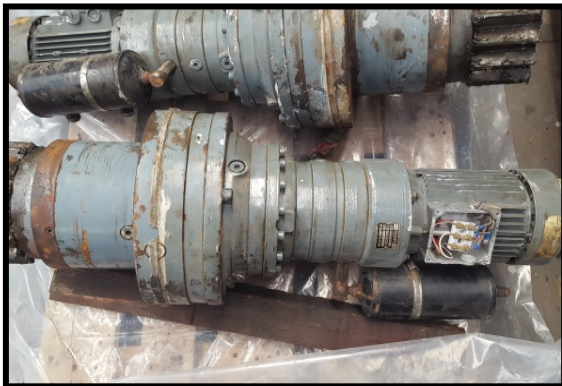
Fig. 3. Reception in Workshop.

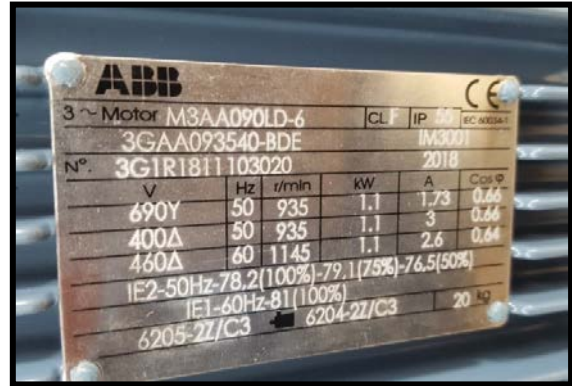
Fig. 4. Identification plate, Electric Motor Installed.

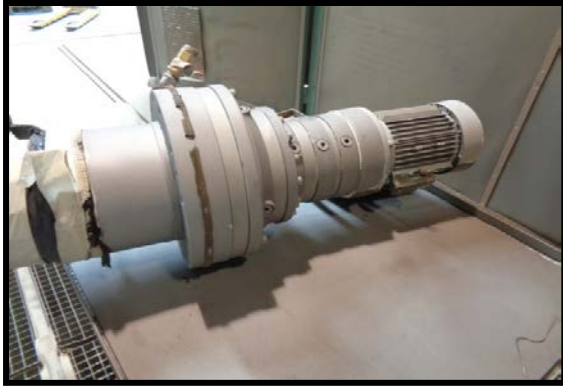
Fig. 1. Blasting treatment

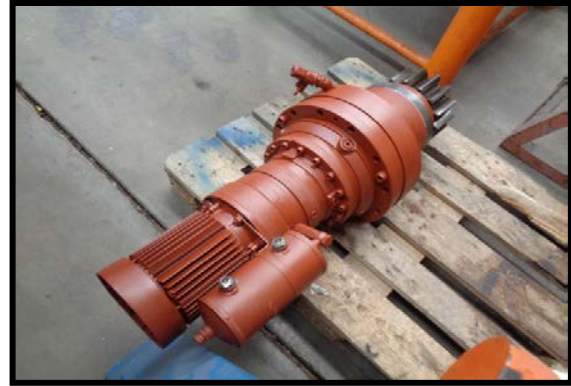
Fig. 2. Anti-oxidant priming

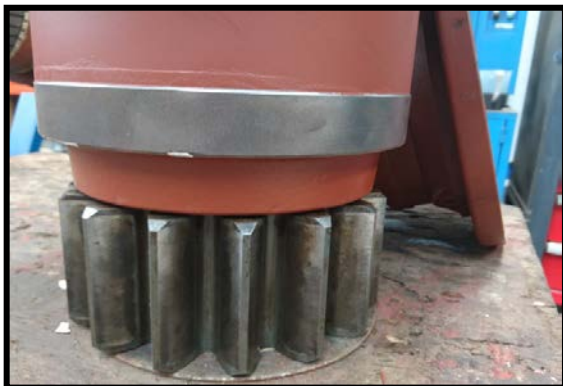
Fig. 3. Piñon in good condition.

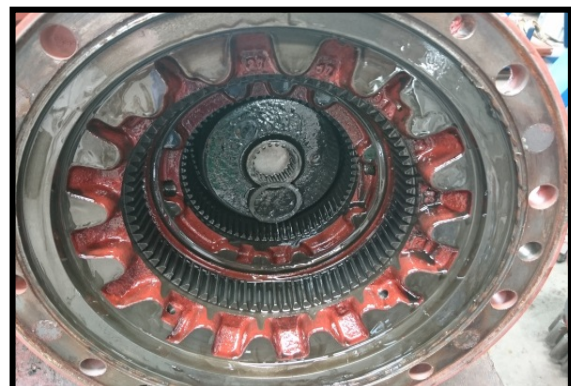
Fig. 4. Disassembly

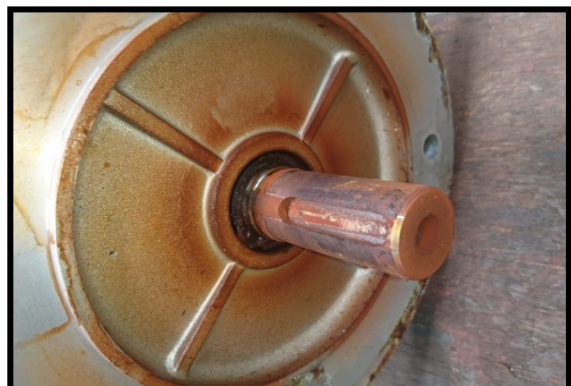
Fig. 6. Shaft Motor and keyway with wear

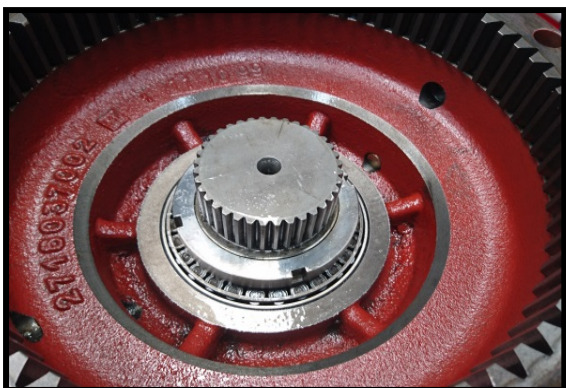
Fig. 7. Cleaning of the gears.

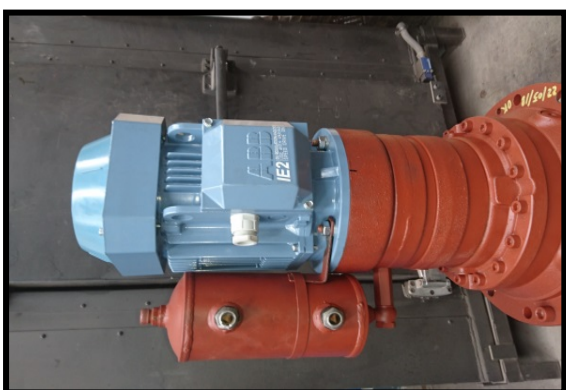
Fig. 11. Replacement Electric Motor.

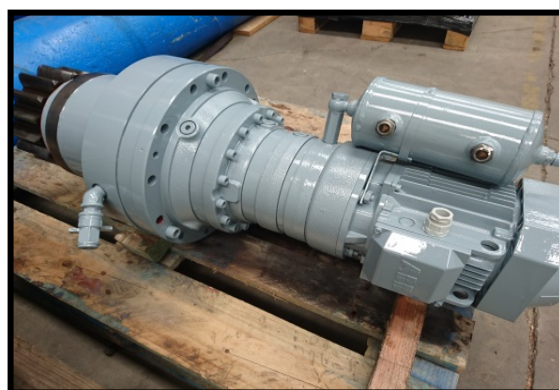
Fig. 12. Final repainting.
